APP ID=09683884

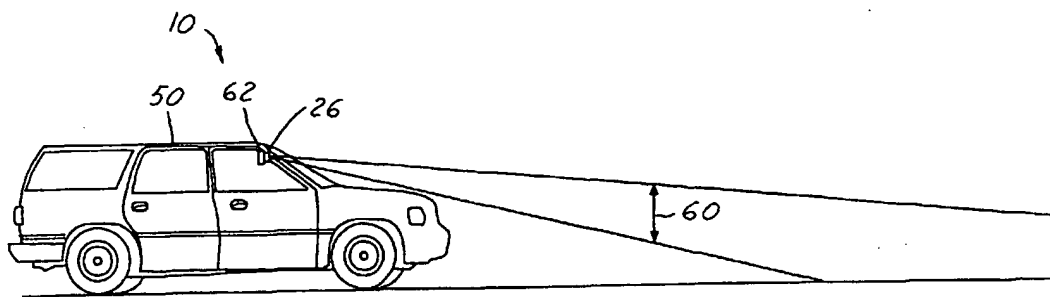
FIG. 4 is a side view of a vehicle 10 with a sensor 50 and a sensor beam 62. The sensor beam 62 is directed at an angle of 60 degrees relative to the ground.
